TEAL LAKE DAM
AUDRAIN COUNTY, MISSOURI
MO. 10082

PHASE I INSPECTION REPORT NATIONAL DAM SAFETY PROGRAM.

Teal Lake Dam (MO-10082), Missouri - Kansas
City River Basin. Audrain County, Missouri
Phase I Inspection Report.

NOVEMBER, 1980

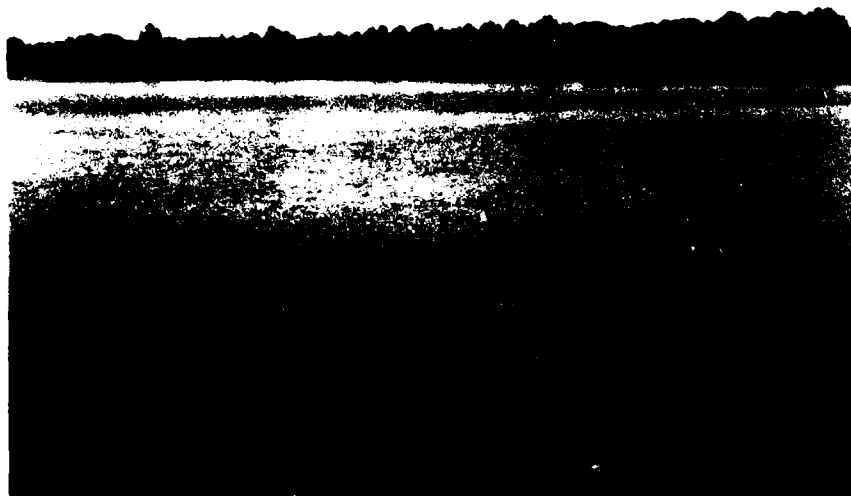
- Photo 12 - View of the reservoir and rim.
